**Total Land Subsidence in the Fort Grant Rd and Willcox Areas, Cochise County
Based on Radarsat-2 Satellite Interferometric Synthetic Aperture Radar (InSAR) Data**

Time Period of Analysis: 1.1 Years 02/25/2014 To 04/09/2015

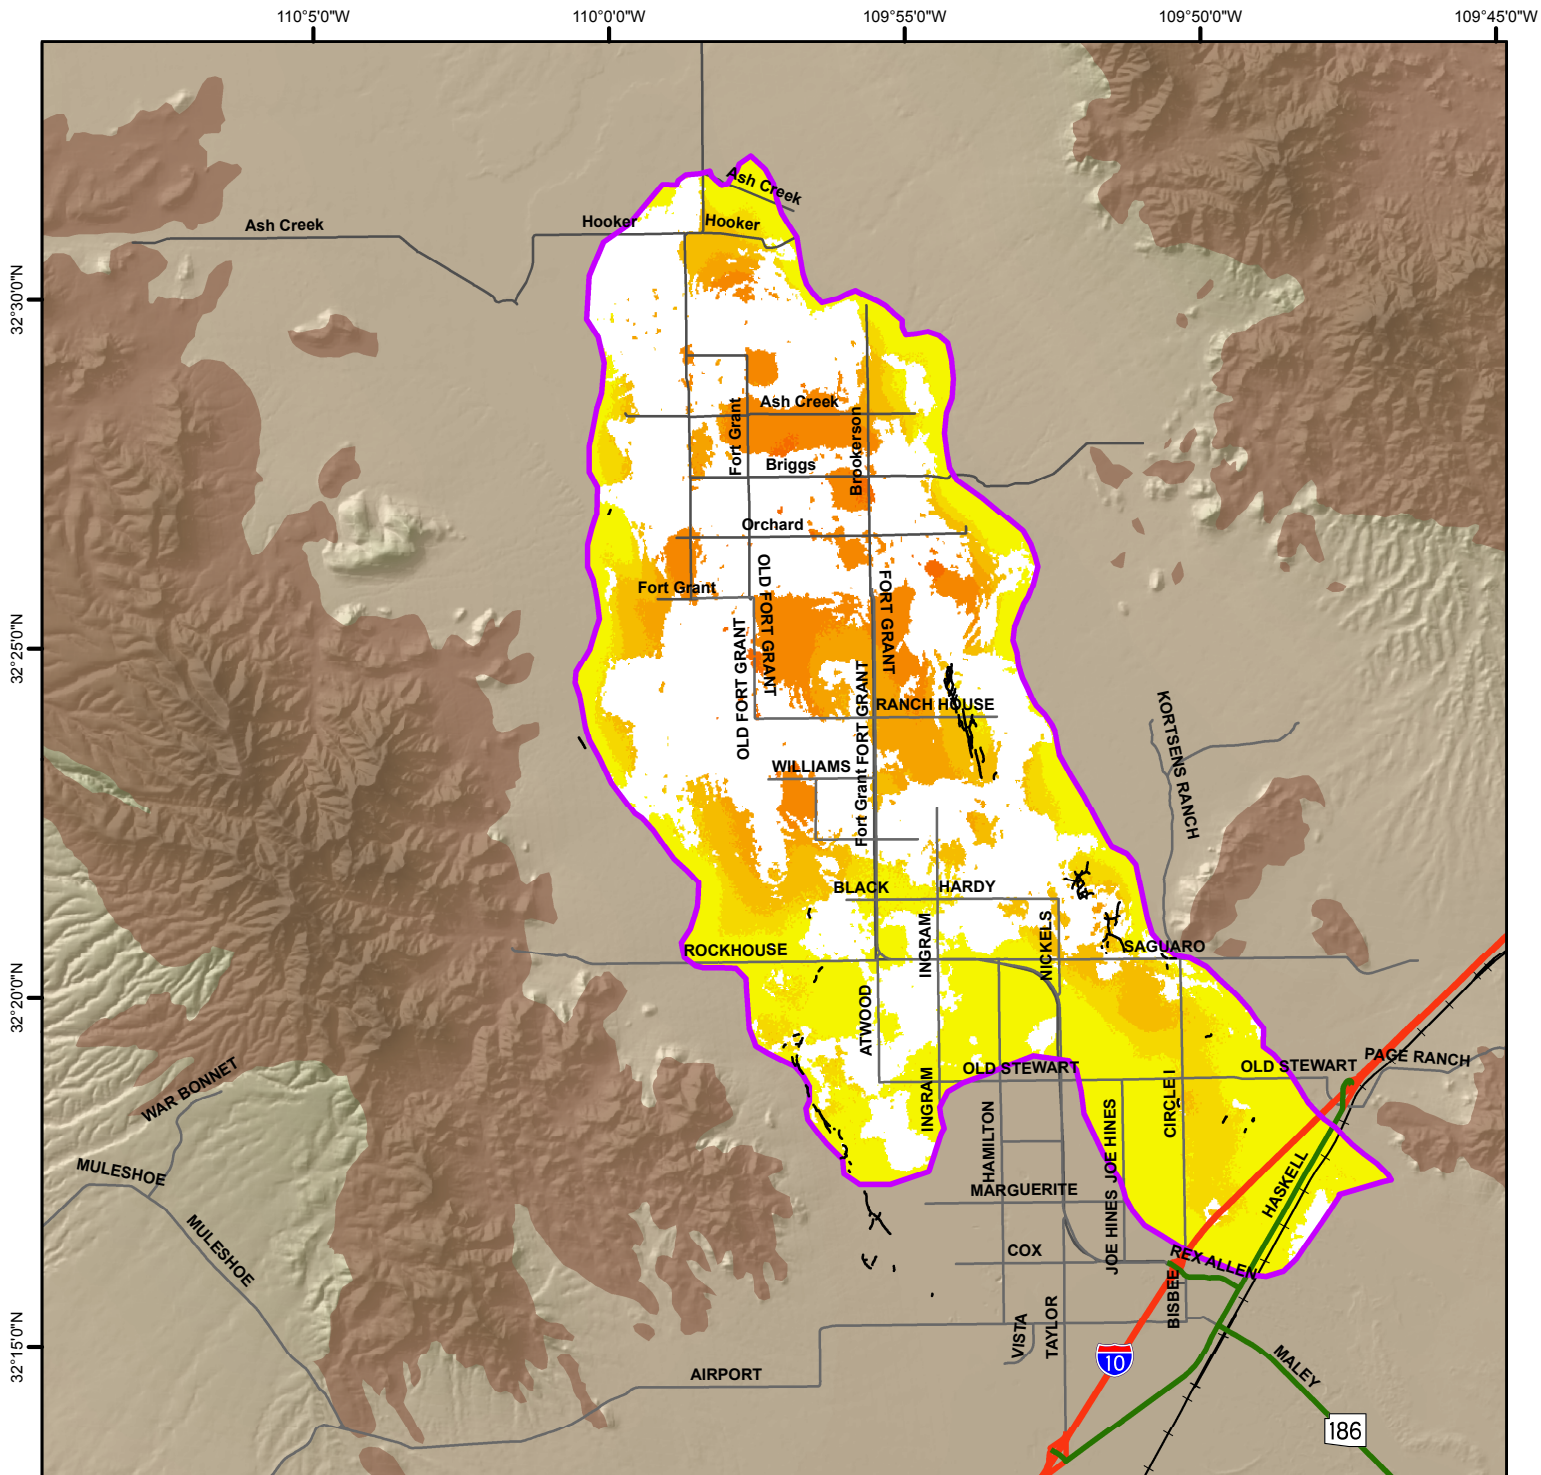
Decorrelation (white areas) are areas where the phase of the received satellite signal changed between satellite passes, causing the data to be unusable. This occurs in areas where the land surface has been disturbed (i.e. bodies of water, snow, agriculture areas, areas of development, etc).

Earth fissures were mapped by the Arizona Geological Survey.
For information on earth fissures visit: www.azgs.gov/EFC
